# Situation Photo Log

Friday, June 1, 2012

Kalamazoo River / Enbridge Spill

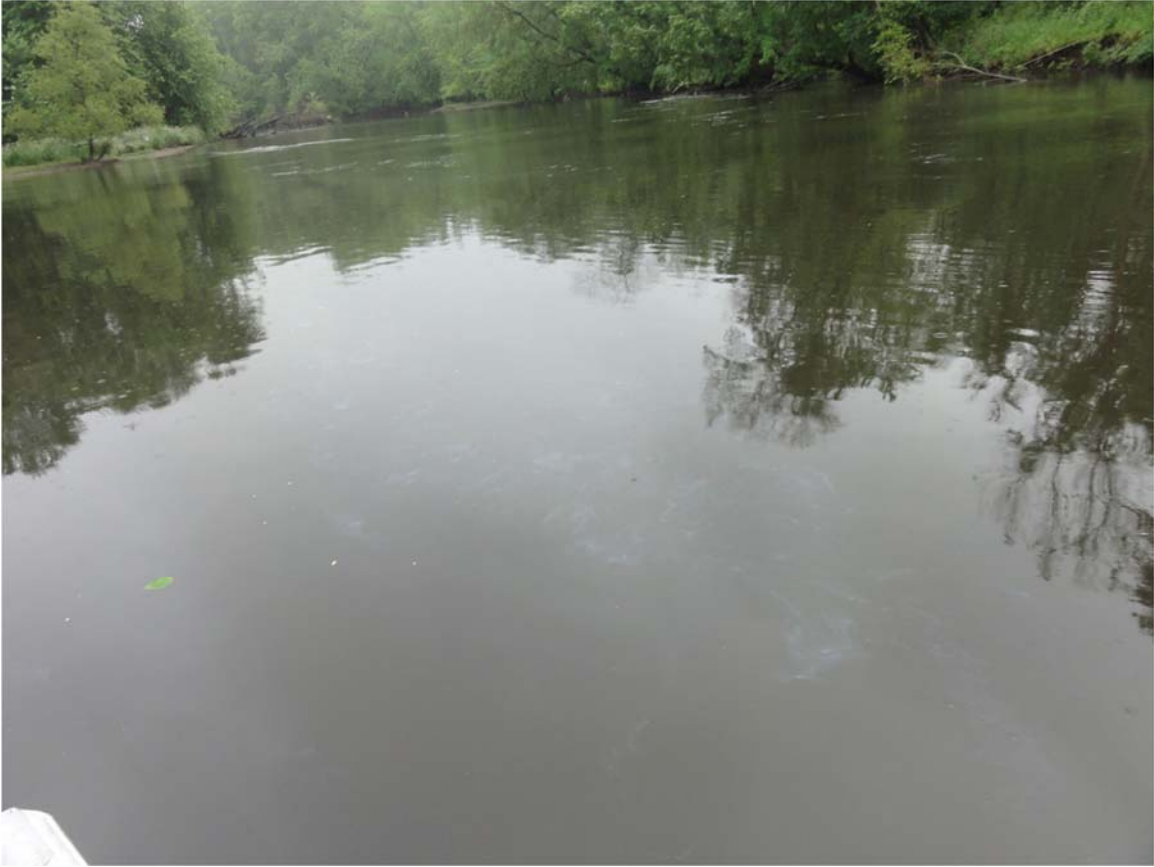
1. MP26.25 RDB sheen observed.

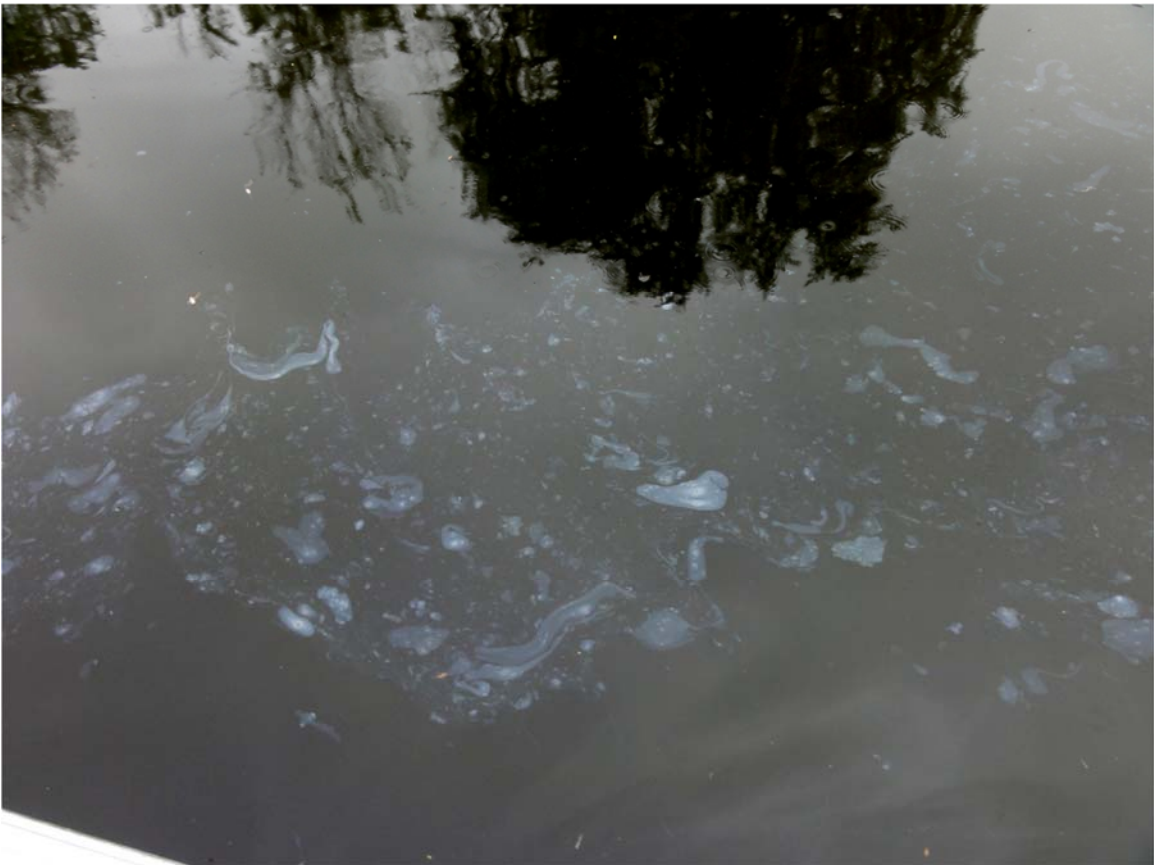
2. MP26.25 RDB sheen observed.

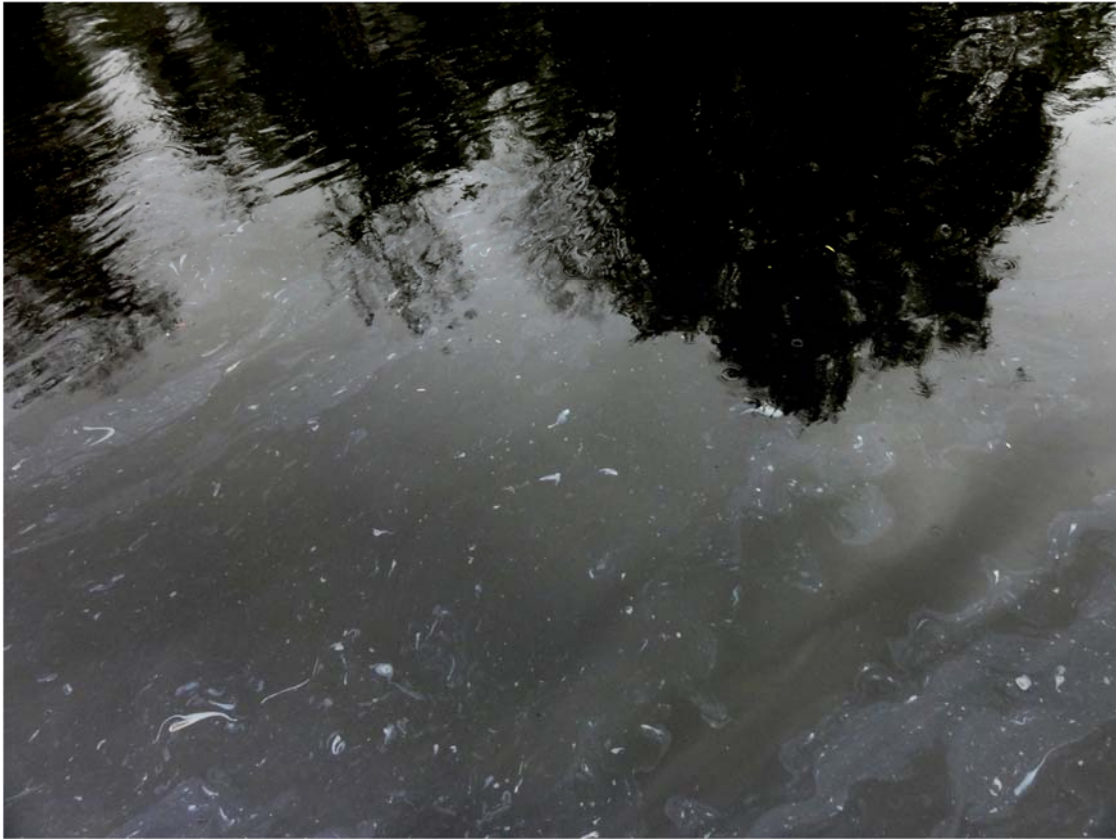
3. MP26.25 RDB sheen observed.

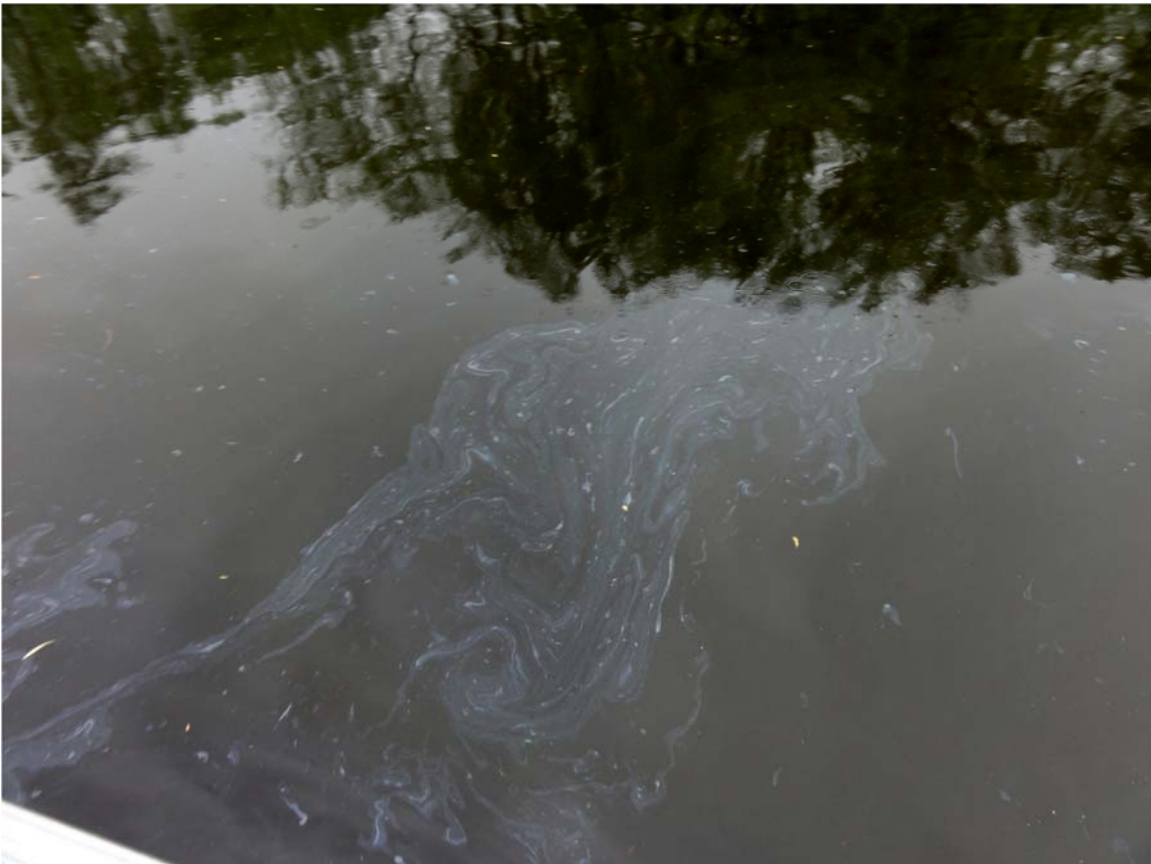
4. MP26.25 RDB sheen observed.

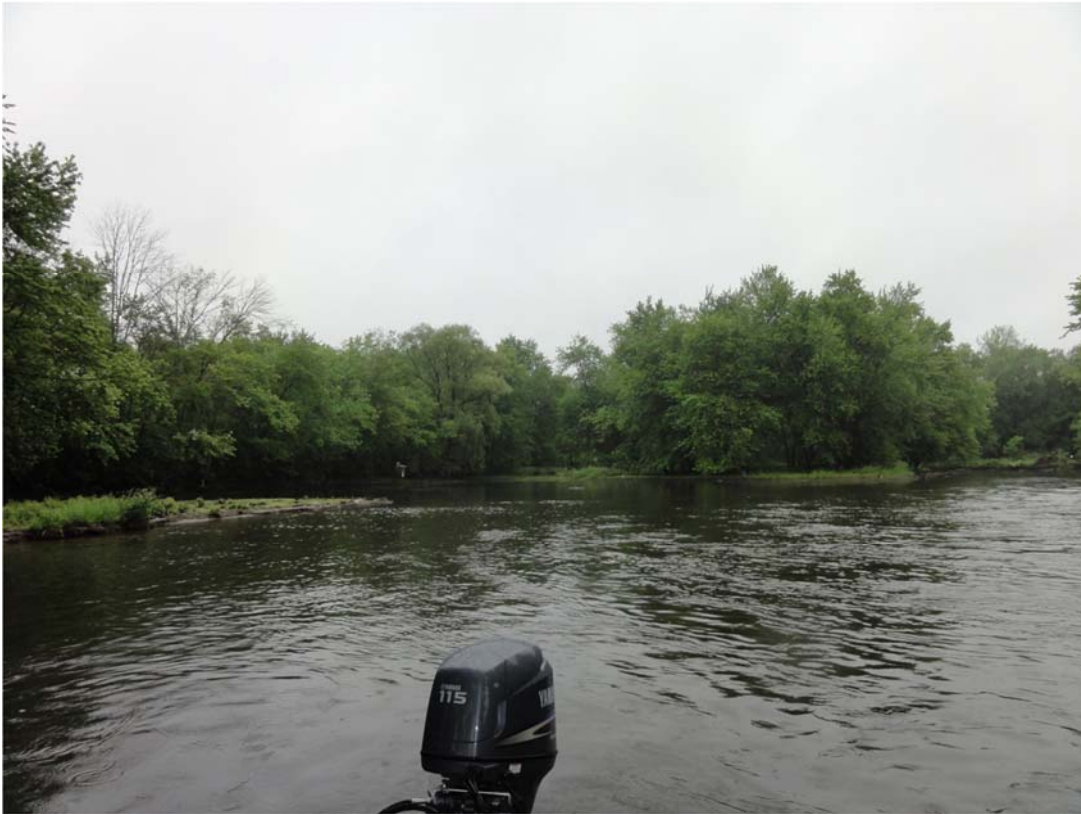
5. MP26.0 RDB sheen observed.

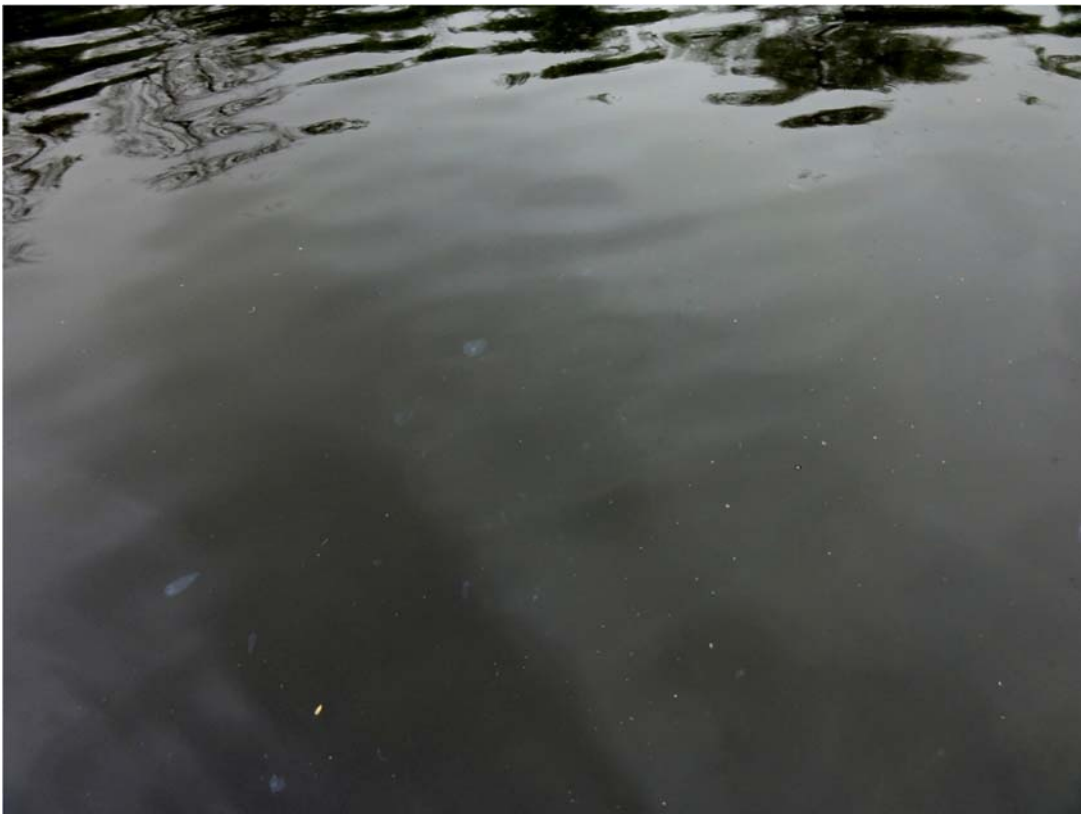
6. MP26.0 RDB sheen observed.

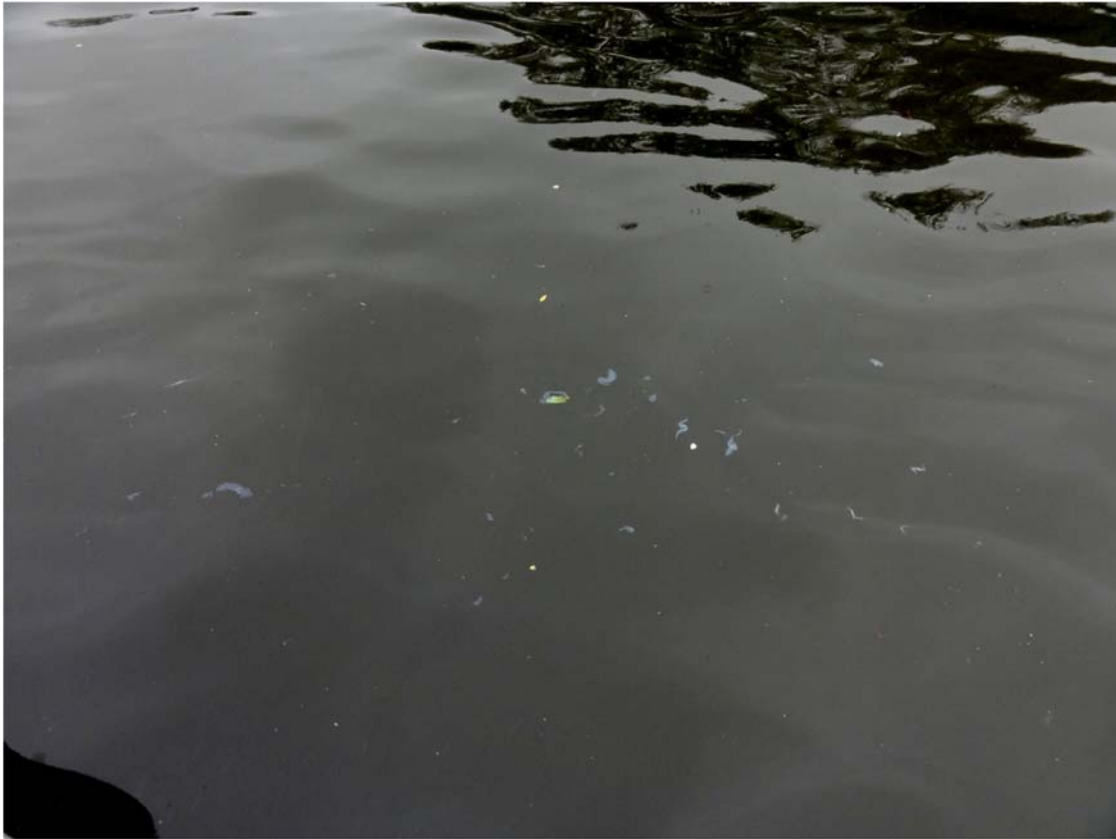
7. MP26.0 RDB sheen observed.

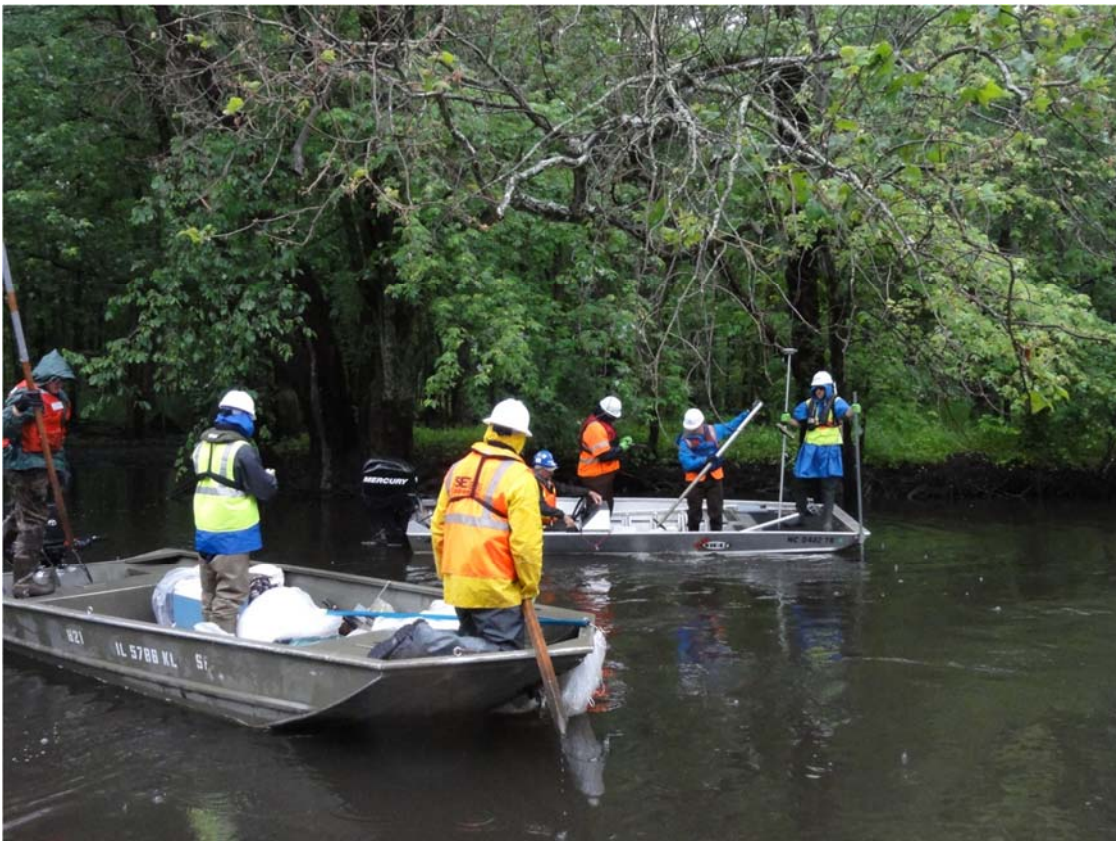
8. MP25.75 RDB poling crew observed.

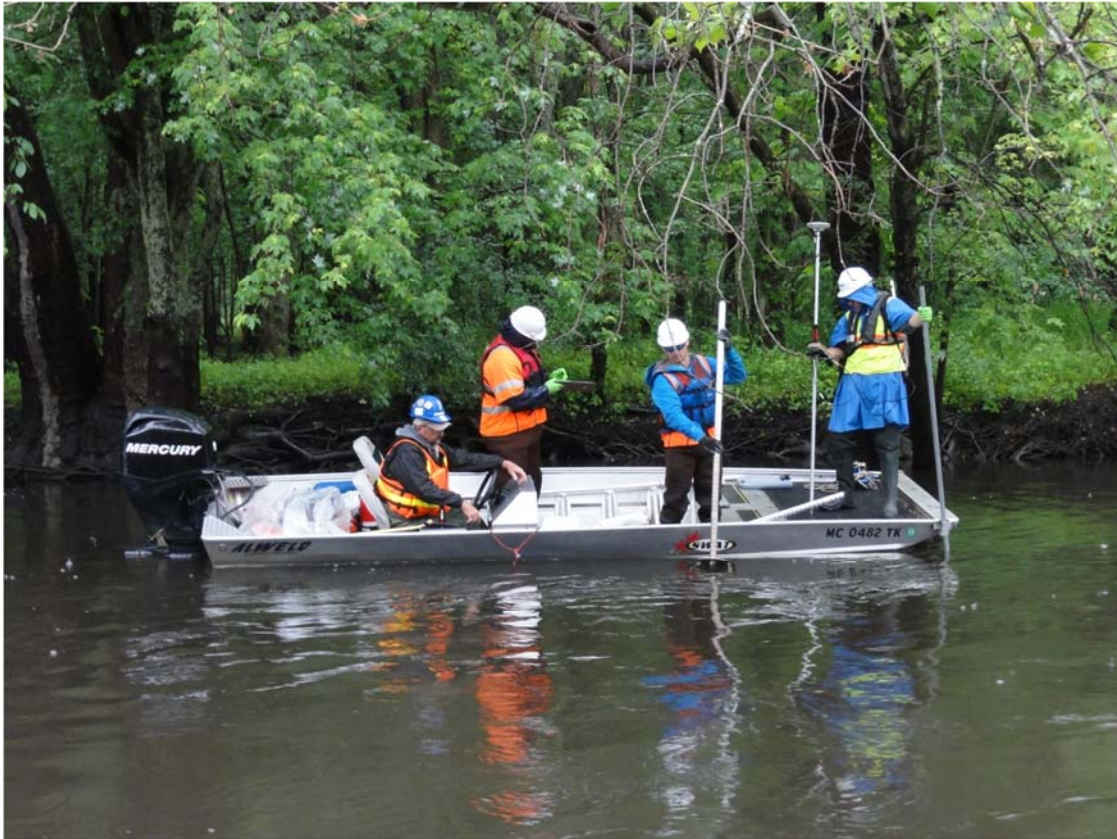
9. MP25.75 RDB poling crew observed.

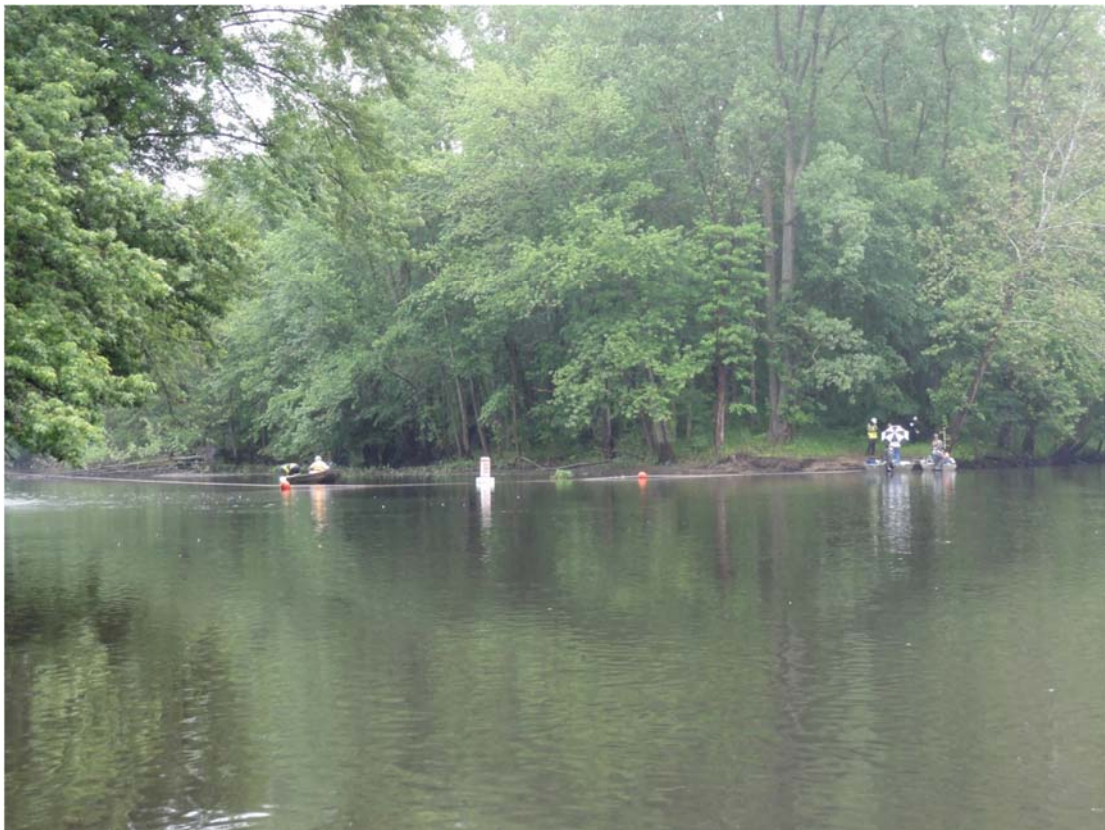
10. MP21.5 observed crew sampling cylindrical sampling devices.

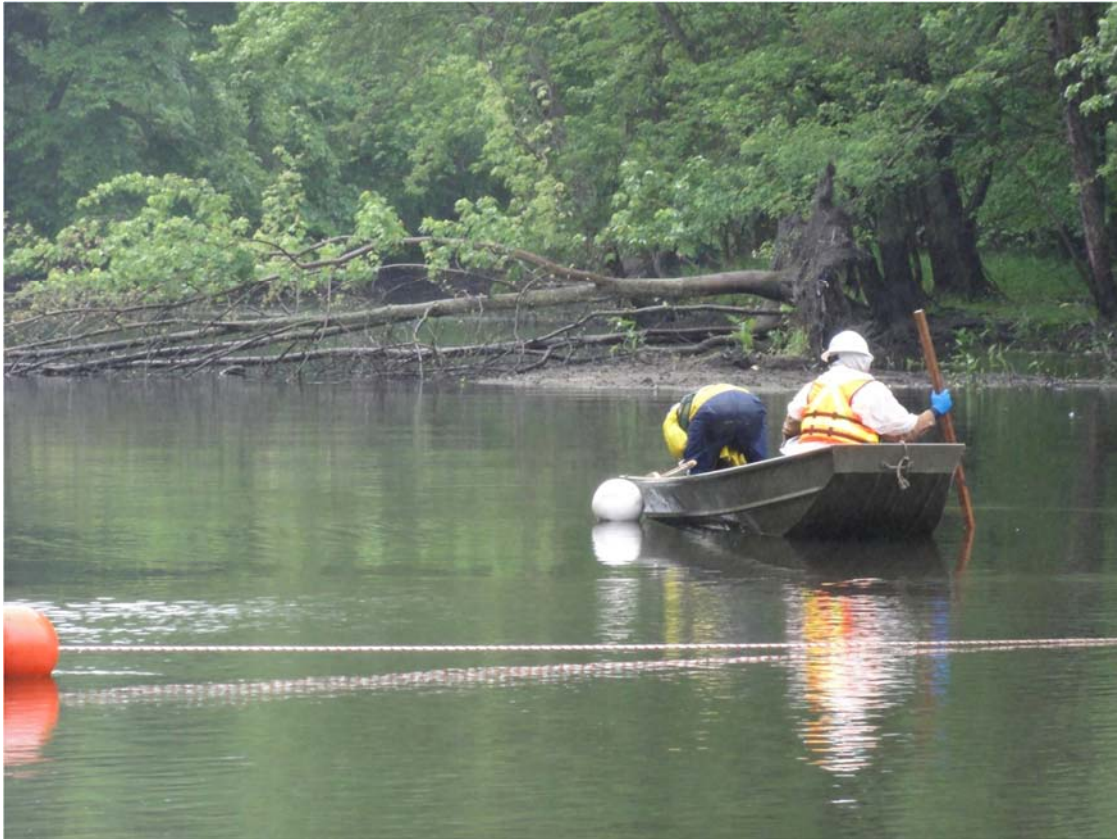
11. MP21.5 observed crew sampling cylindrical sampling devices.

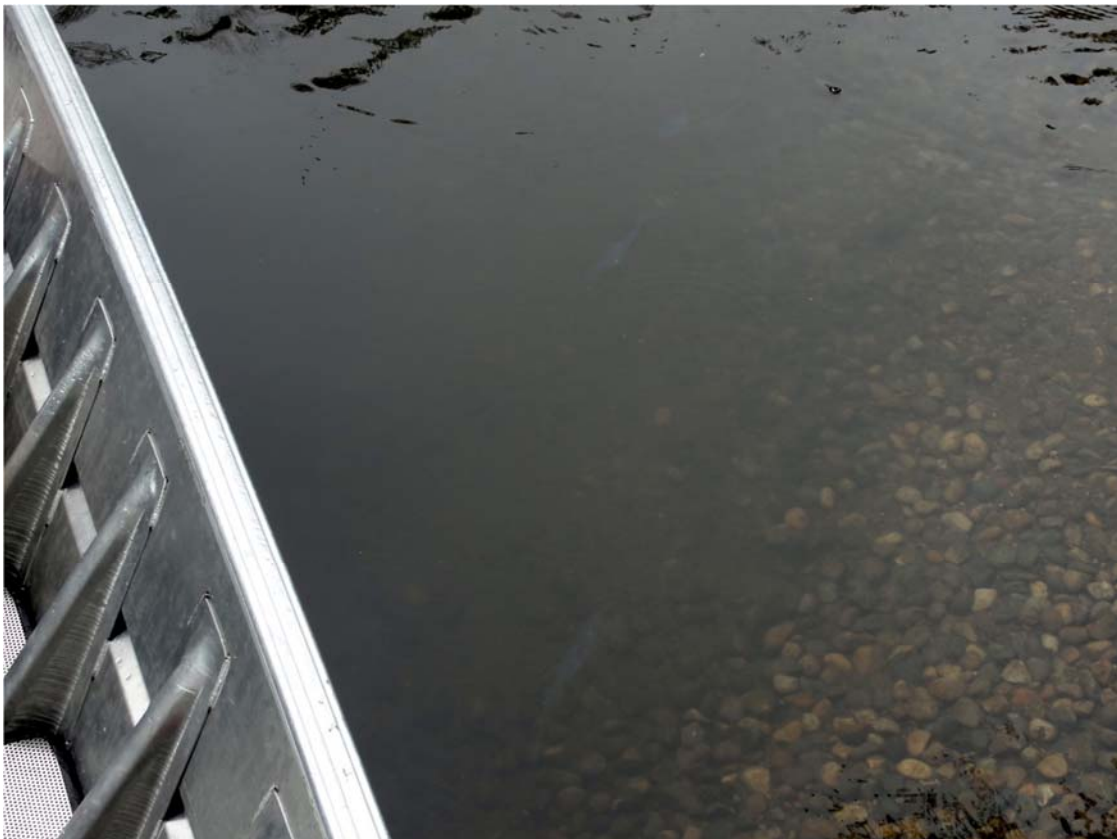
12. MP27.0 Shady Bend Campground sheen observed around dock boats.

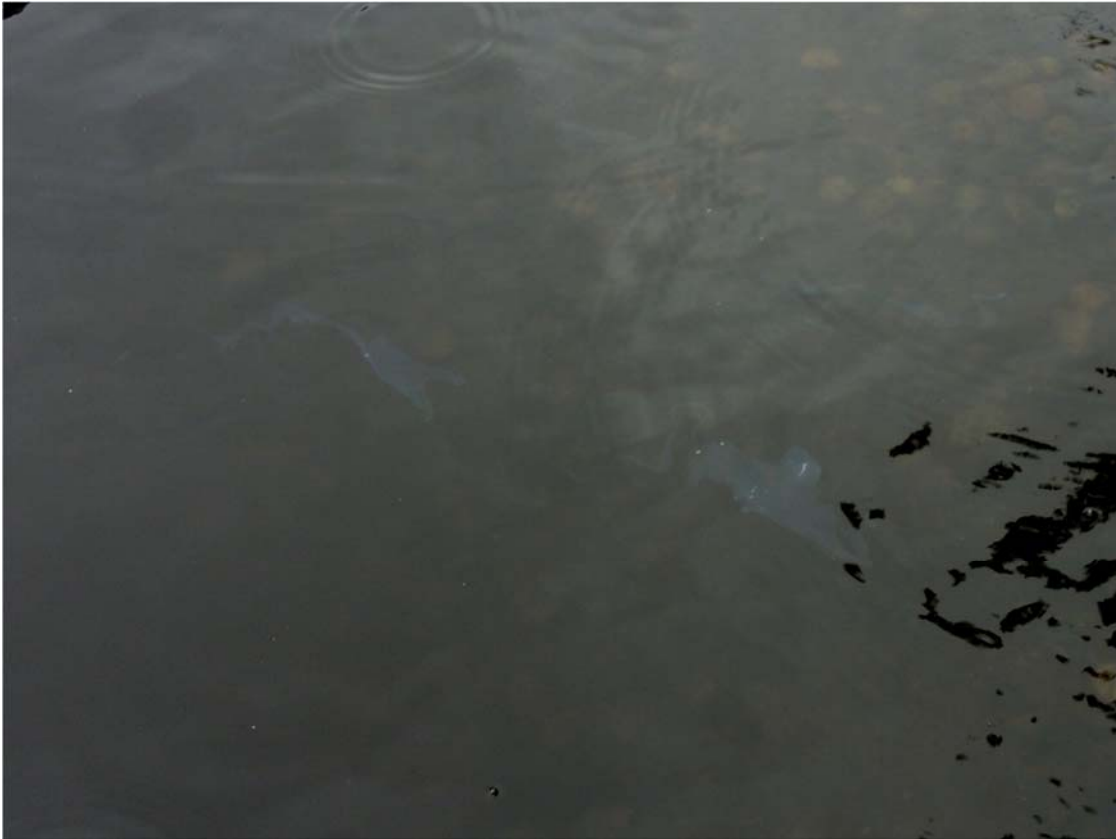
13. MP27.0 Shady Bend Campground sheen observed around dock boats.

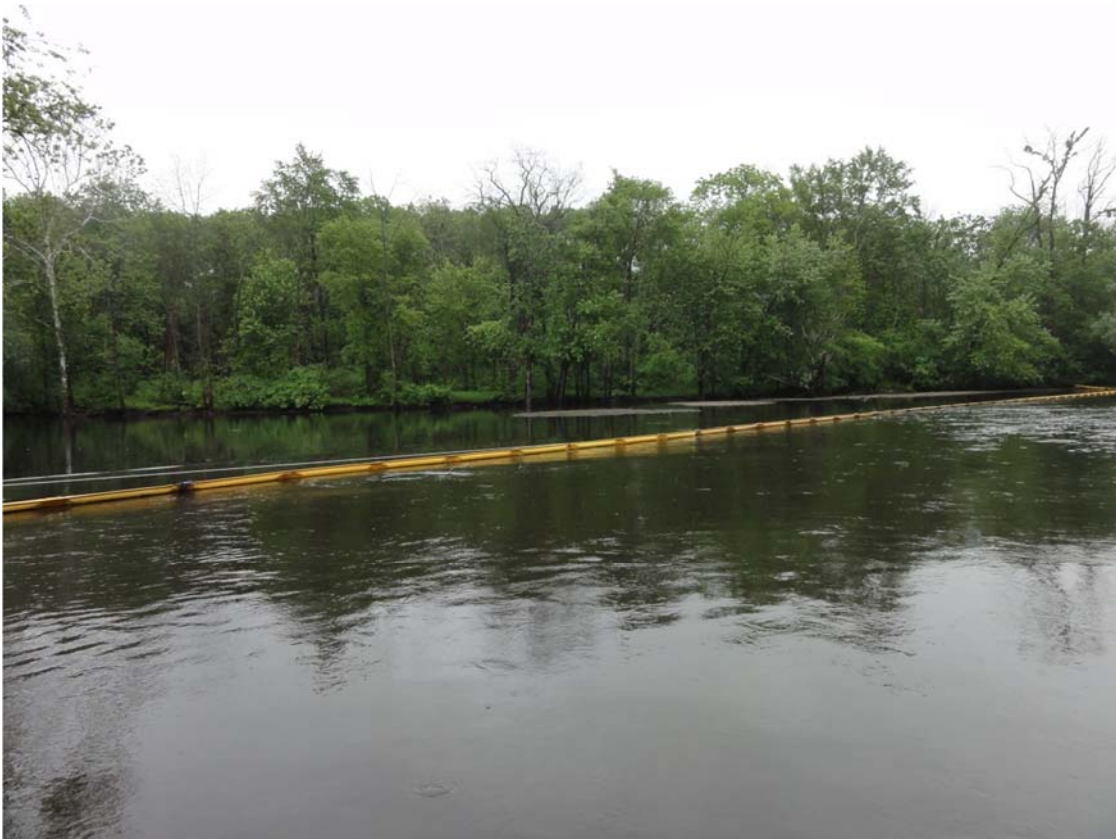
14. MP30.8 sheen observed within boom.

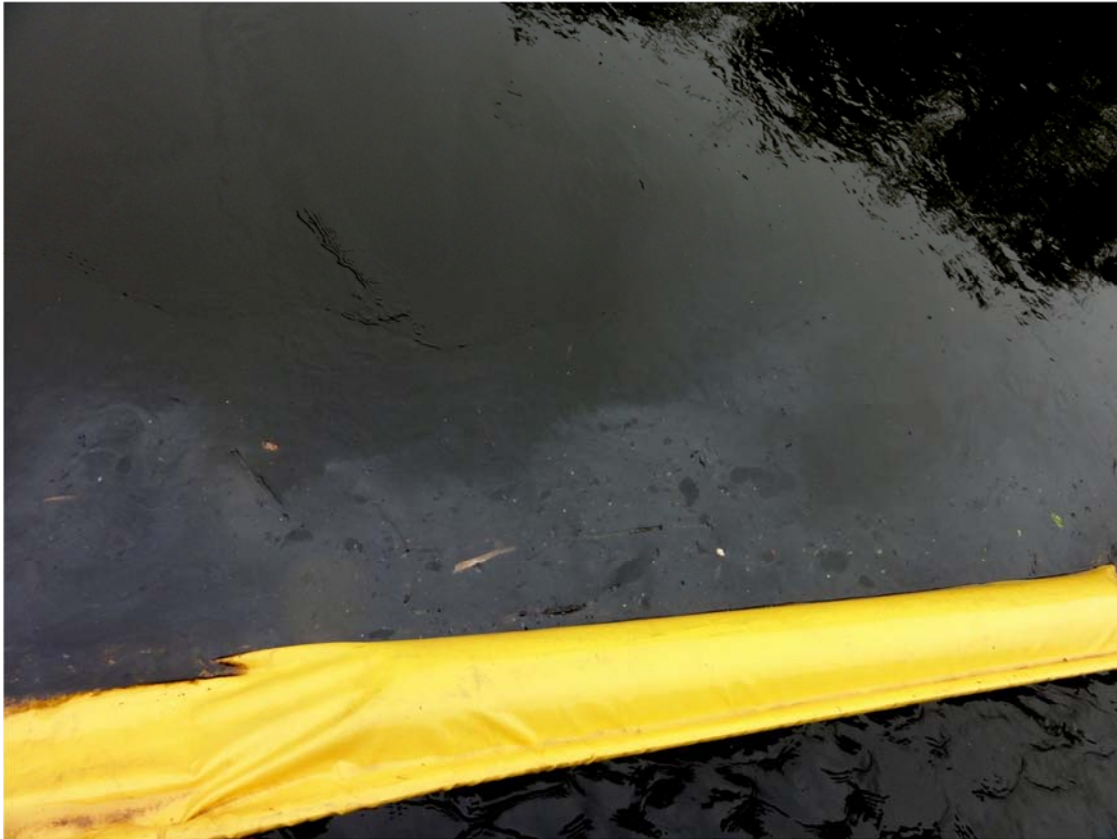
15. MP30.8 sheen observed within boom.

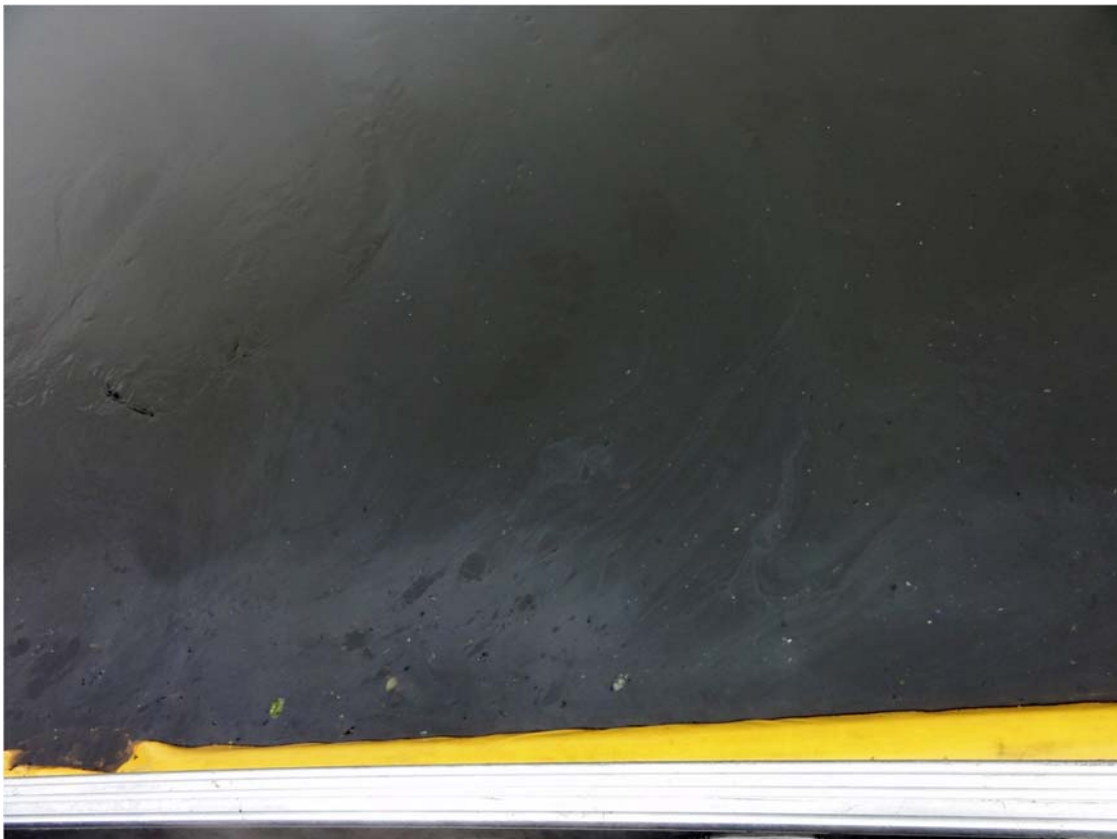
16. MP30.8 sheen observed within boom.

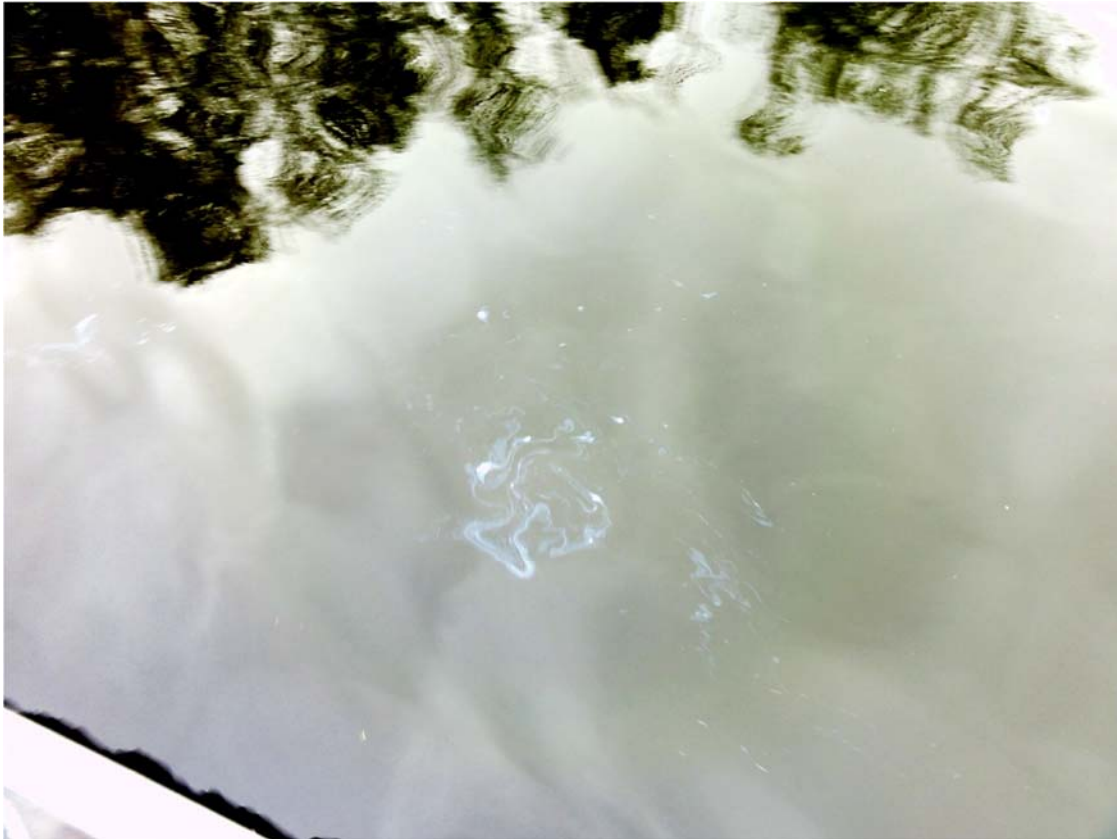
17. MP36.25 sheen observed within center of river channel.

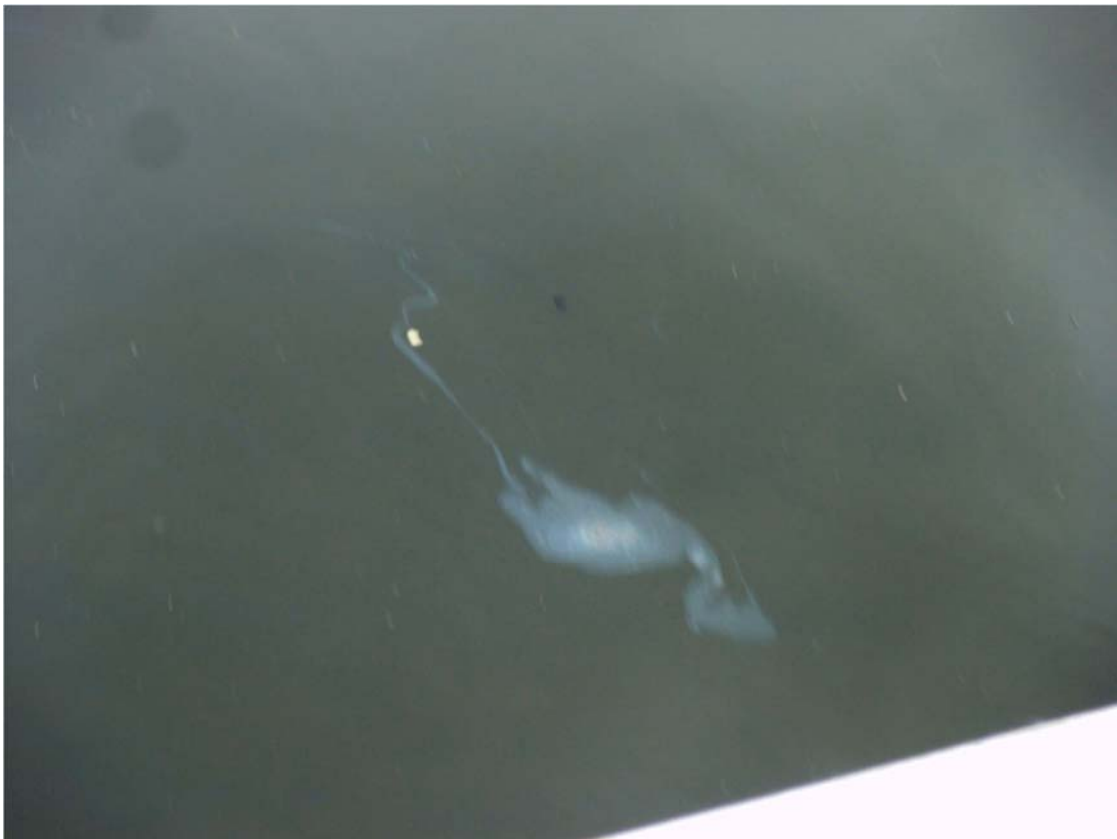
18. MP36.25 sheen observed within center of river channel.

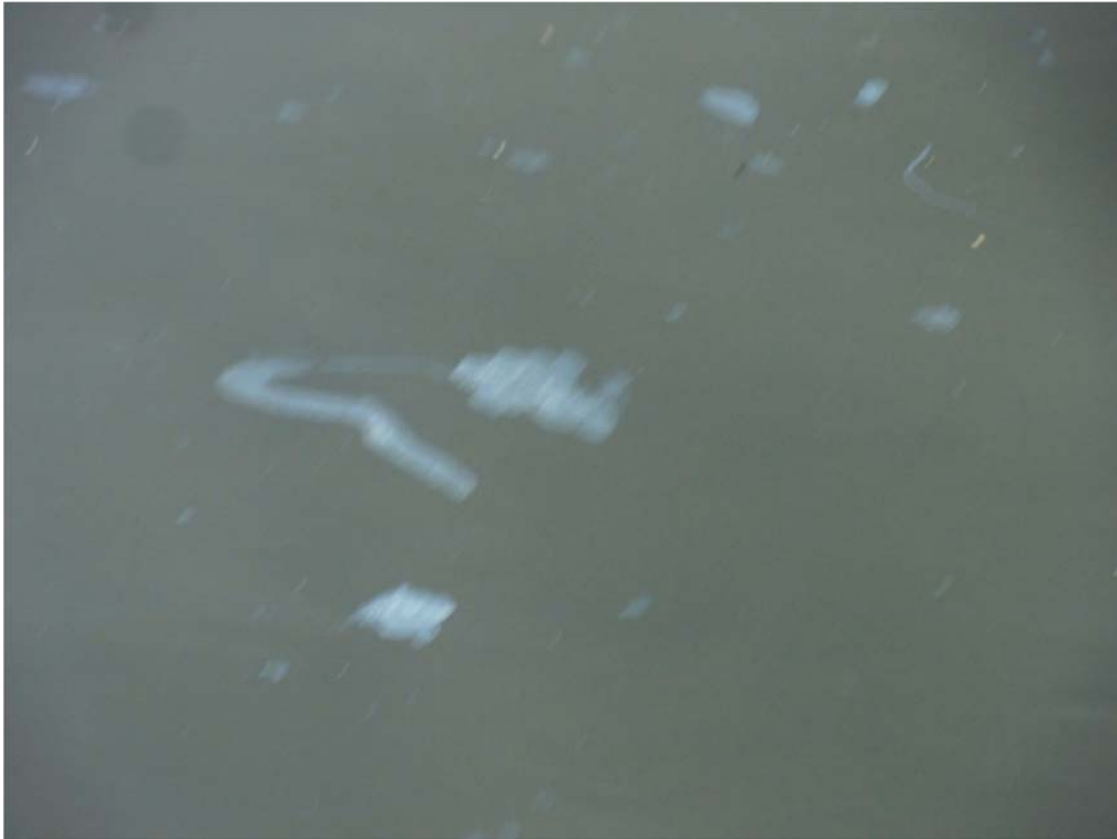
19. MP36.25 sheen observed within center of river channel.

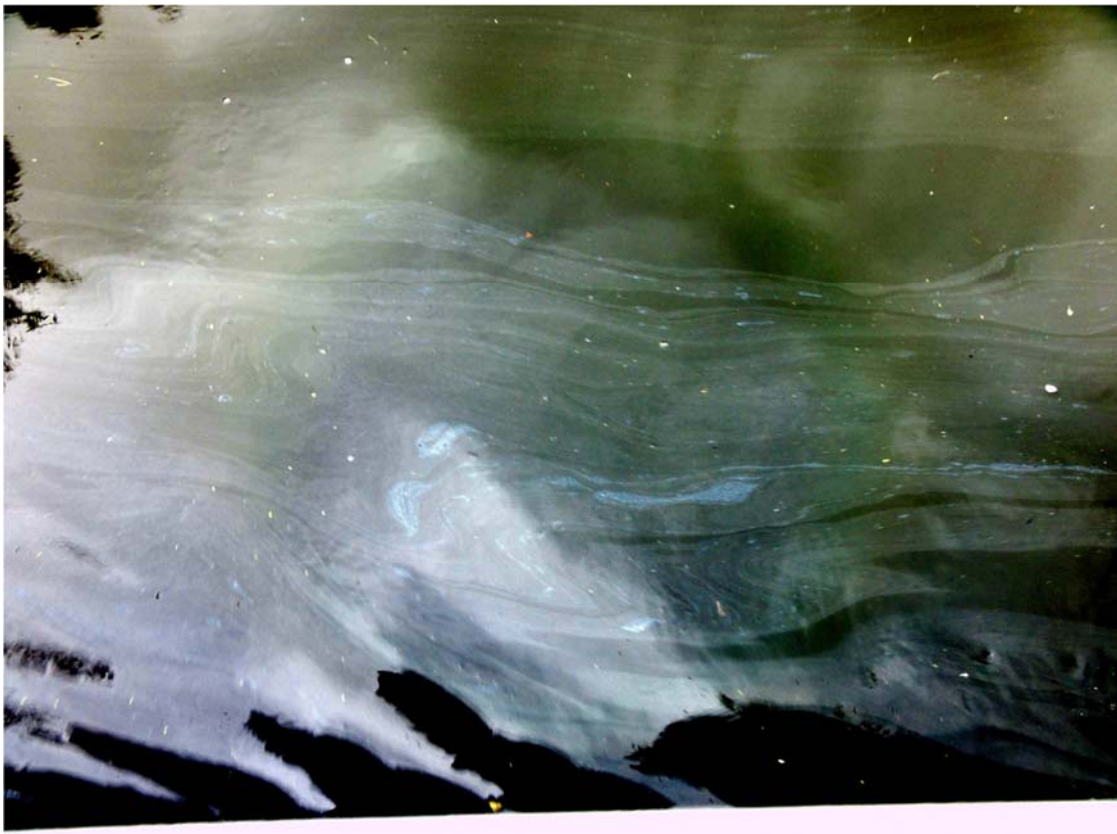
20. MP36.5 LDB sheen observed.

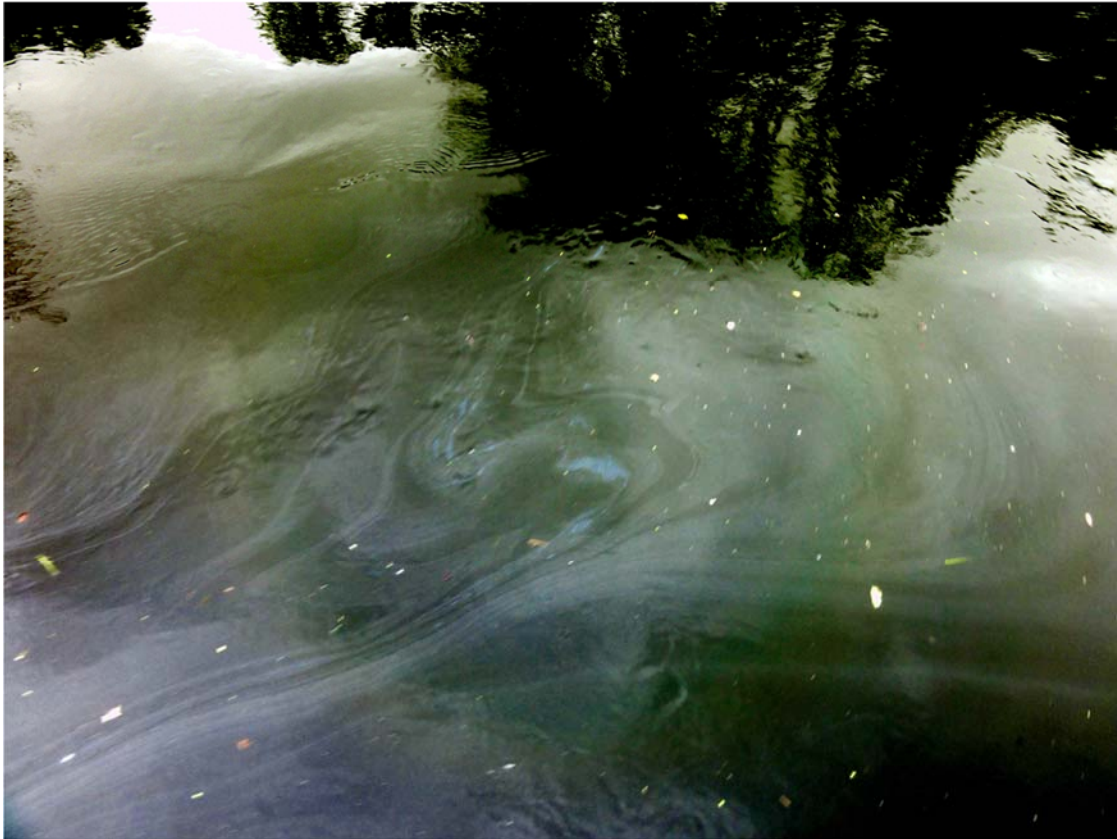
21. MP36.5 LDB sheen observed.

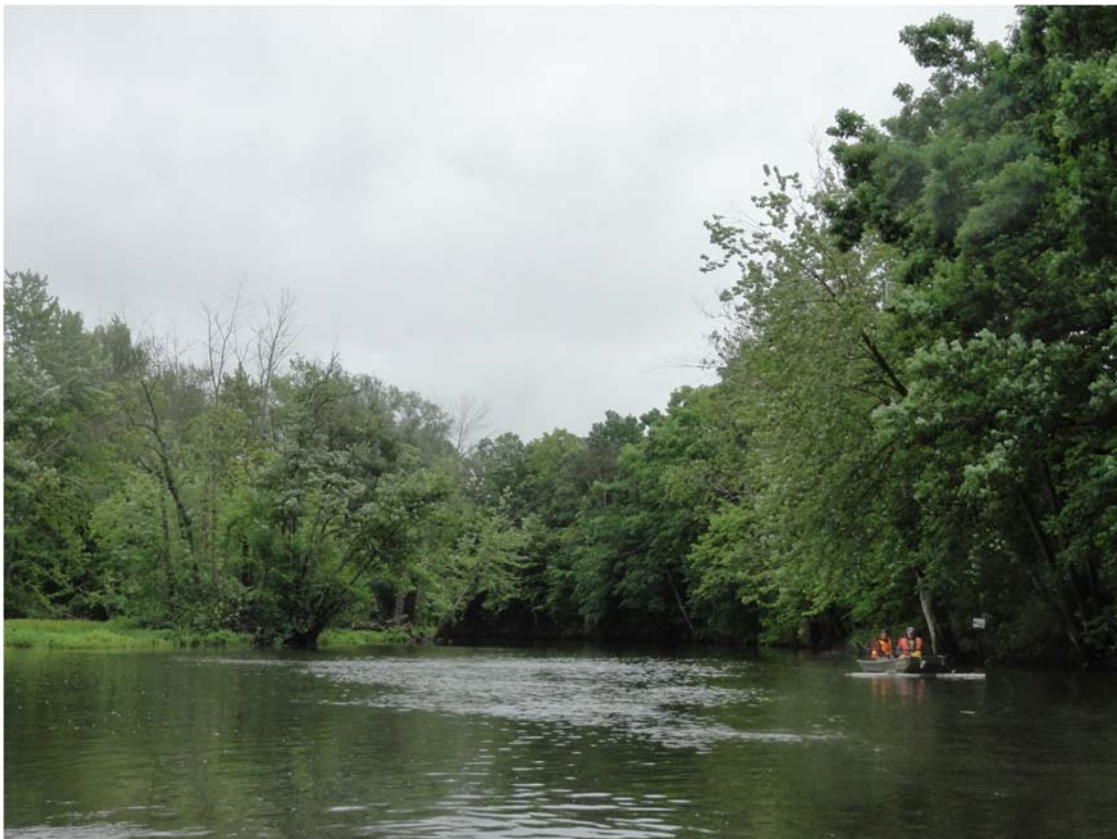
22. MP36.25 sweep boat responded to sheen observation.

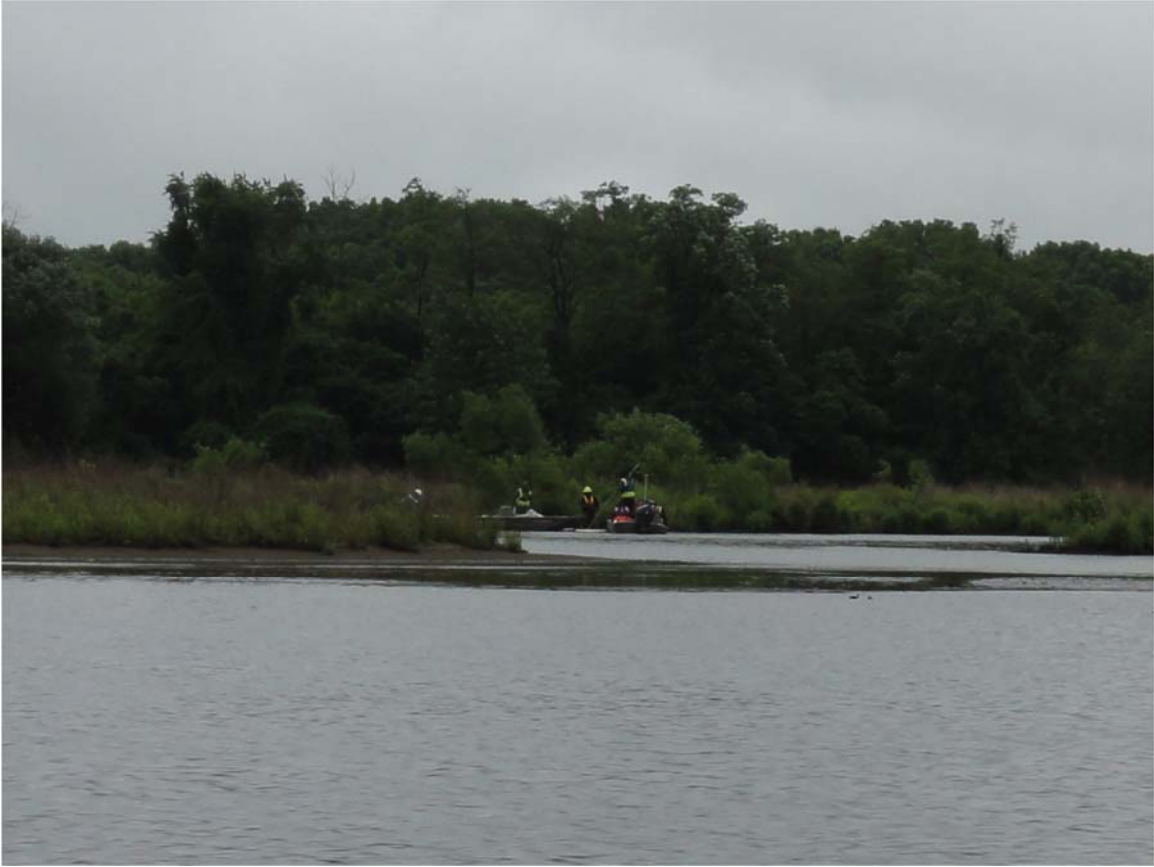
**23. Morrow Lake Delta poling crew observed.**

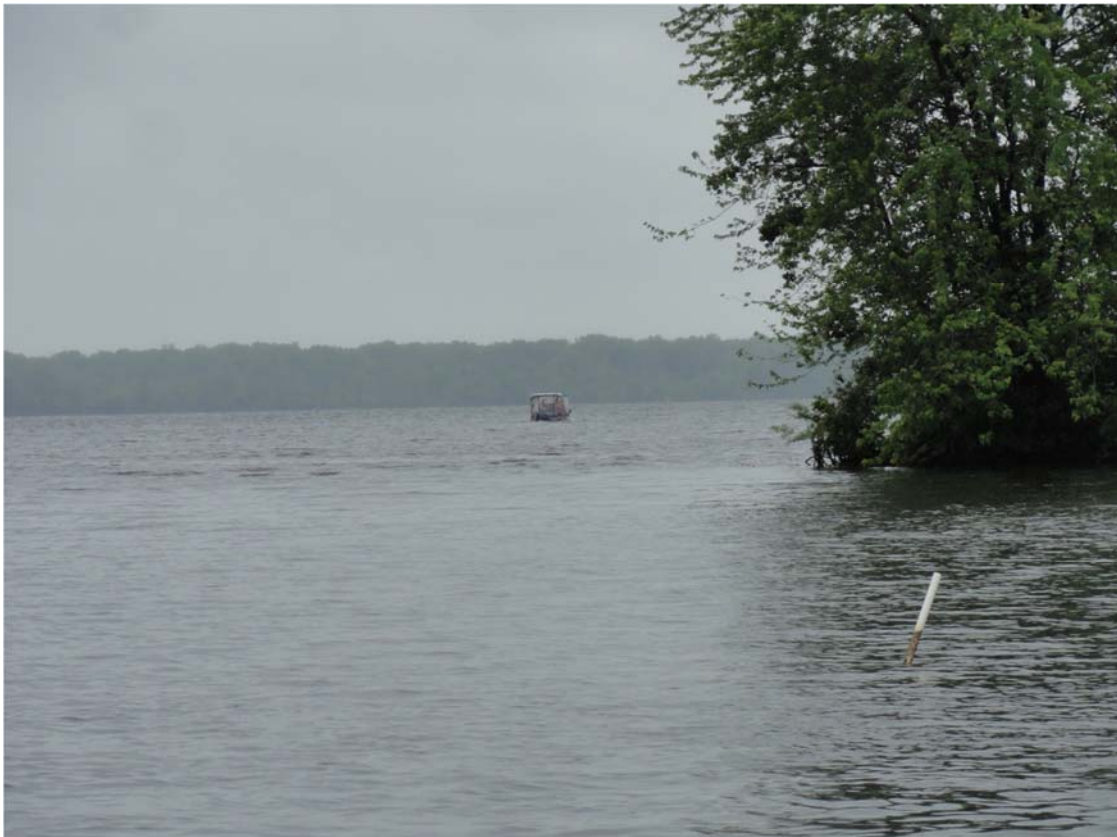
**24. Morrow Lake velocity data collection observed.**
